Technical Memo

Project Name: Campus Hot Spot Assessment

Client: St. John's University

Re: Summary of Findings

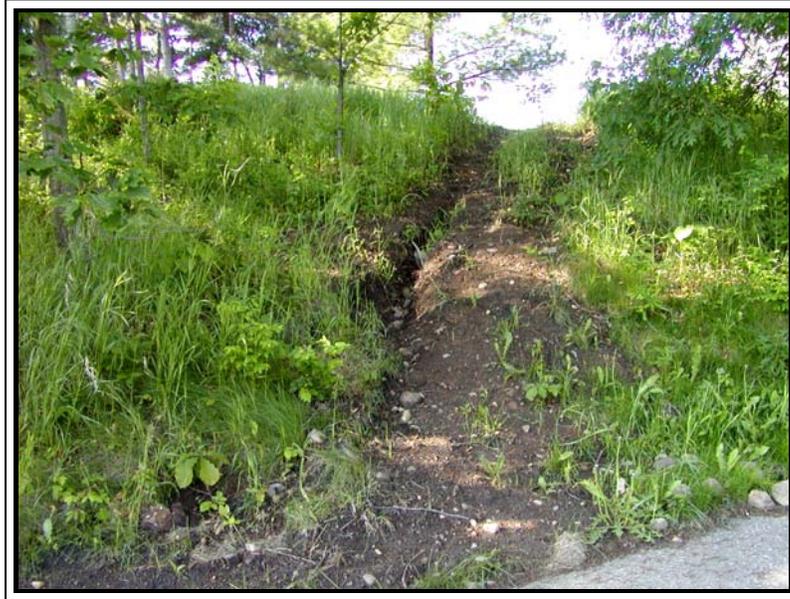
Figure 1 – Unstable slope behind tennis court

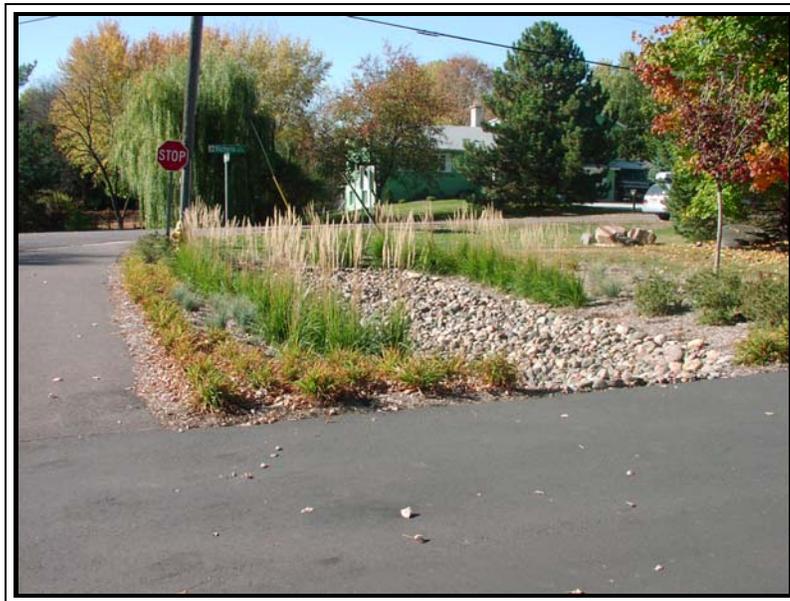
Figure 2 – Illustration of a roadside rainwater garden

Divert pipe flow to create an infiltration gallery (a.k.a. rainwater garden) to provide stormwater treatment. Preliminary calculations indicate that runoff from rains of up to ¾-inch could be treated before entering Stumpf Lake. A two-cell infiltration gallery was evaluated on the west side of the major four-way intersection at the campus entrance. If

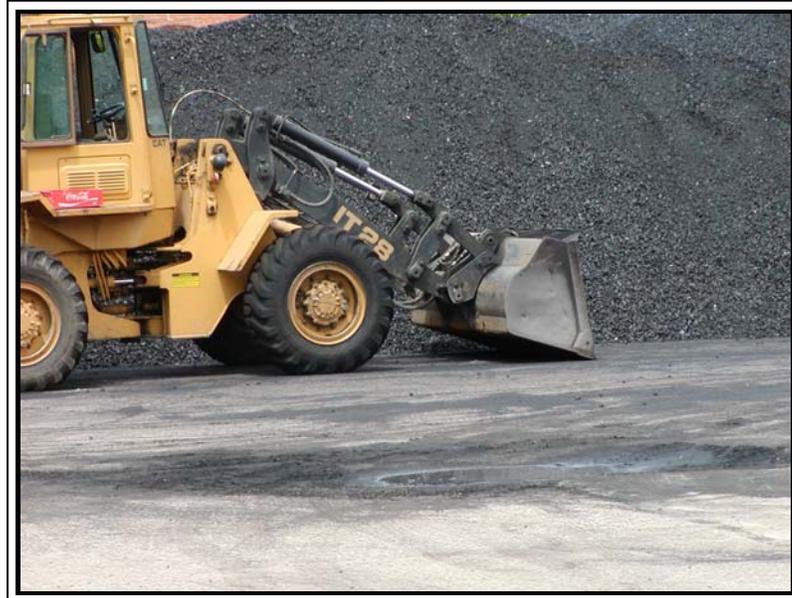
This area is highly influenced by the coal storage practices at the power plant (Figure 3). It also has a substantial amount of impervious area (64%). Particulates and TSS are the key pollutants of concern in this area. Several opportunities exist to address this hot spot.

Figure 3 – Clogged catch basin at power plant

Retrofit the existing drop manhole on the west side of County Road 159 with a swirl concentrator unit. Preliminary calculations were made assuming this recommendation would be implemented with a V2B1-type swirl concentrator (model 4) which is sized to handle a peak runoff flow of up to 4.3 cfs. This would accommodate peak runoff from storms over 1.0 inch (almost up to 1.5 inches). If this recommendation is implemented, moving directly into system design would be an appropriate next step.

The existing corrugated metal pipe and concrete drop manhole that are above grade would be removed. New manholes would be installed in conjunction with the V2B1 unit. This allows for low flows (up to 4.3 cfs) to be routed into the swirl concentrator while disruptive high flows from infrequent storms are allowed to bypass the system. This approach also allows for the new structures and treatment system to be placed below grade, improving the visual aesthetics of the area.

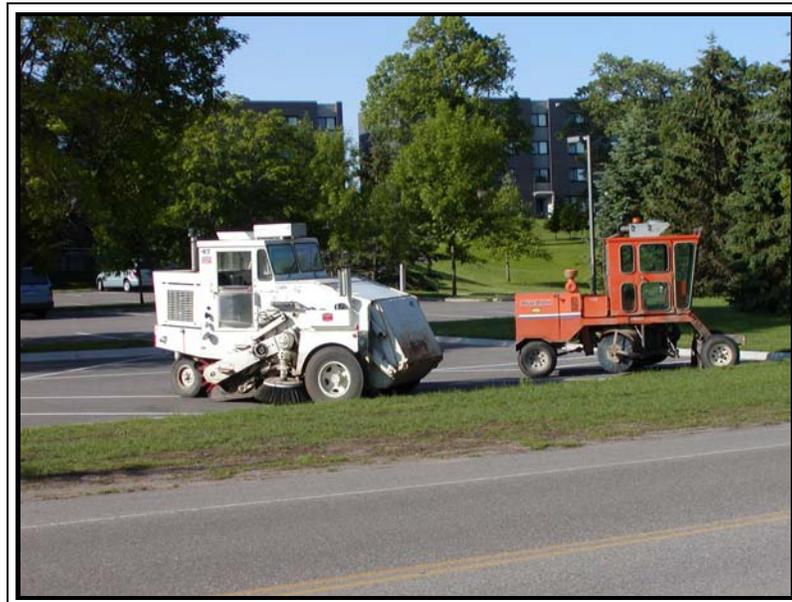
Figure 4 – Street and parking lot sweeping is critical

The recommendation for this area is to employ good housekeeping efforts within the drainage area itself. For example, it would be beneficial to maintain the roadways and paths here on a more vigorous level by means of sweeping. Another option for future consideration might be procuring and installing catch basin filtration devices at key junctions within ST3 to treat stormwater runoff as it enters the conveyance system. Inspection of the device is typically performed quarterly, with maintenance being performed as needed. Vacuuming of accumulated sediment and debris is followed by evaluation/replacement of the filter media. A common alternative to this filtration device is to utilize manholes that have a sump feature. However, in this case, any existing manholes would need to be entirely removed and replaced with a new manhole and sump.
